Thermography Inspection of Terex Roadmix MTV

03 May. 07

Eric Baker
Marketing Manager
Roadtec, Inc.

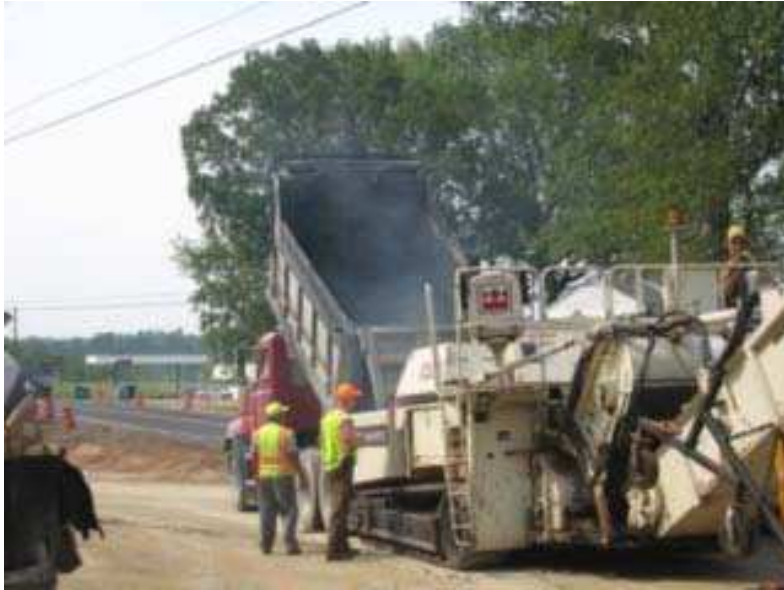
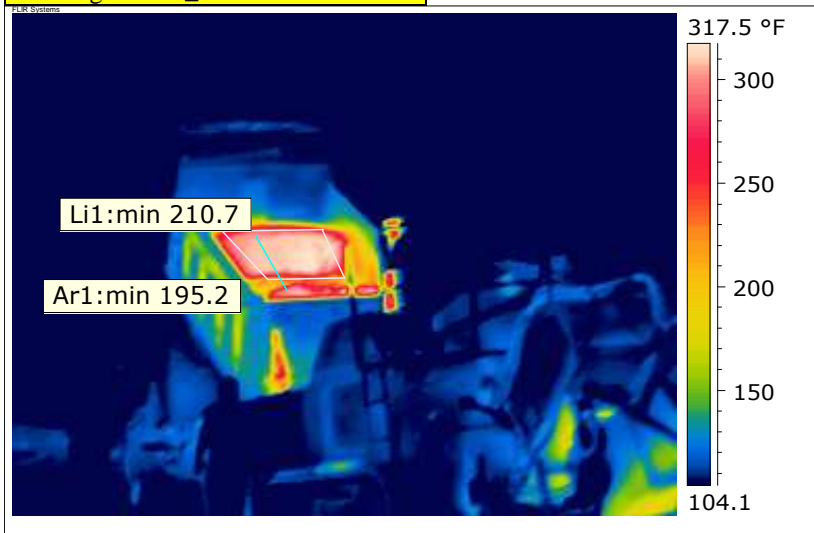
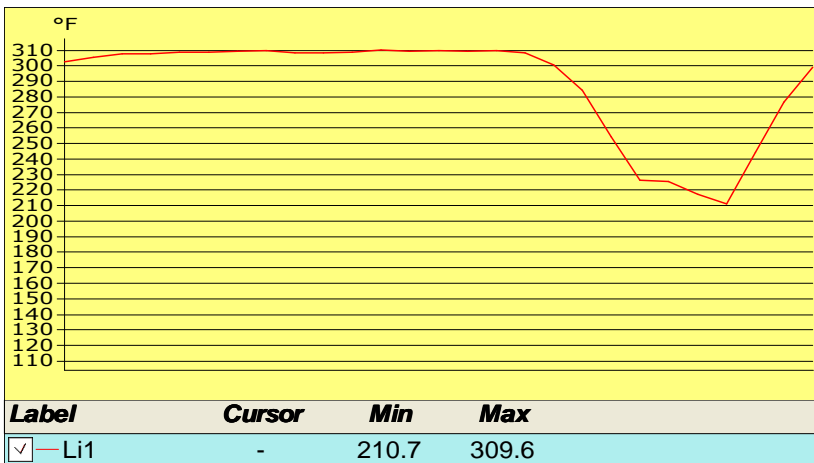
Thermogram: IR_0071.JPG 5/2/2007

Ar1 is an area box shown in white on the infrared image. The minimum temperature within the box is displayed in the label and the maximum temperature is displayed in the table below. The Li1 graph displays so that the top of the truck is left side of graph and the bottom of the truck is the right side of the graph.

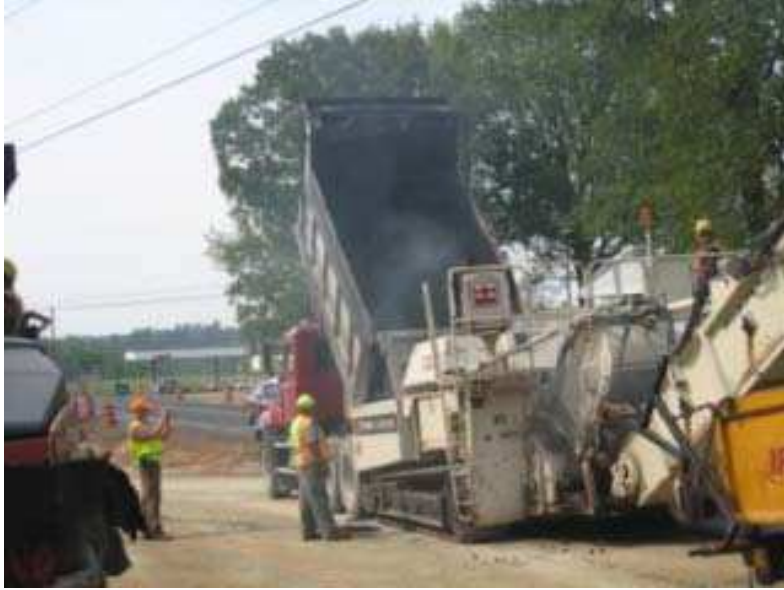
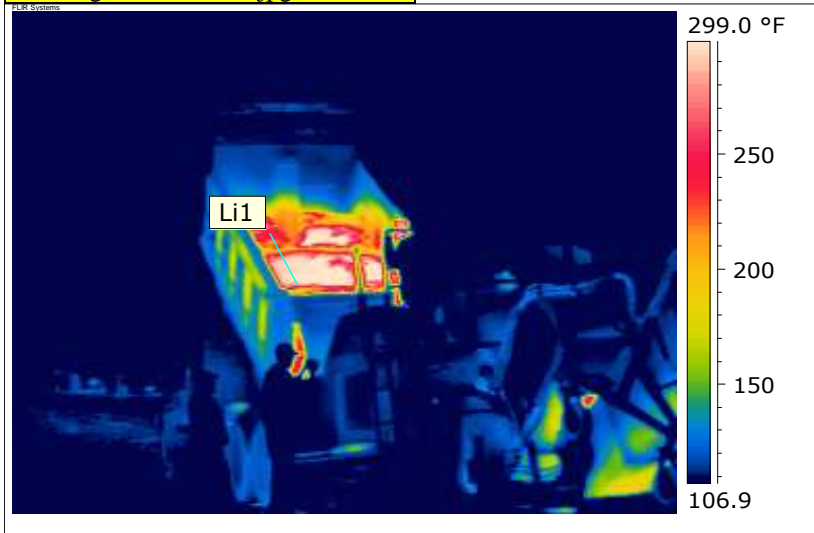
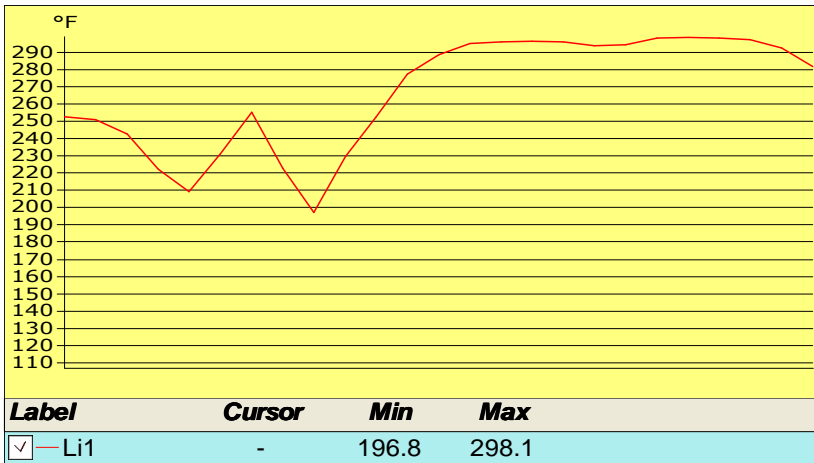
Thermogram: IR_0072.jpg 5/2/2007

Truck segregation. Haul time was approximately 20 to 30 minutes and all trucks had tarps. Again the graph for Li1 displays from the top of the truck bed to the bottom of the truck bed.

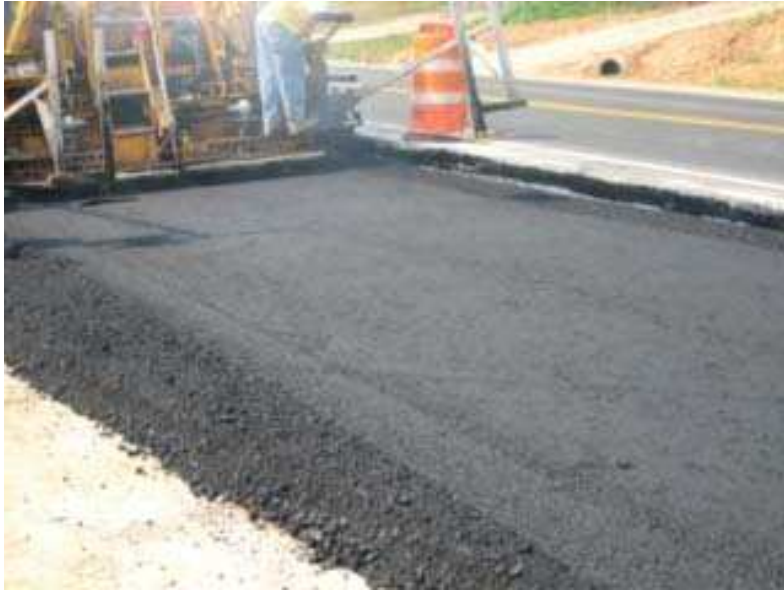
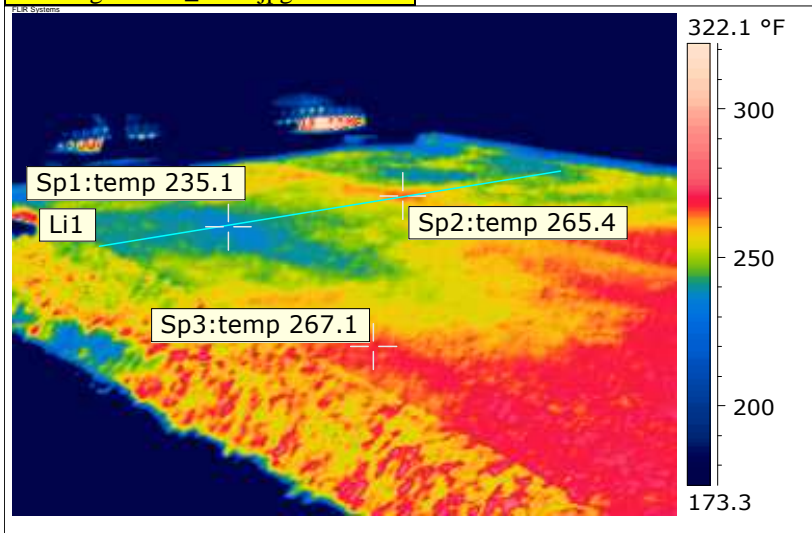
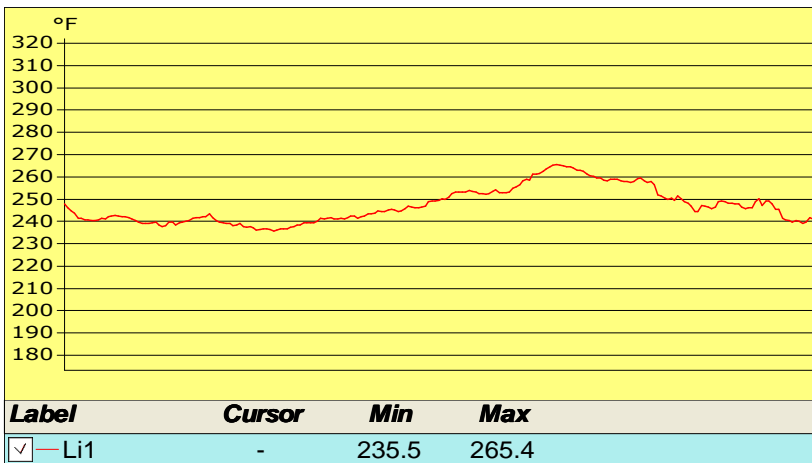
Thermogram: IR_0074.jpg 5/2/2007

End of load segregation is apparent. Differences of 30 degrees across the mat.

The Terex Roadmix Material Transfer Vehicle did not satisfactorily remix. This is supported by the non-uniform mat behind the paver. Truck end load segregation areas were readily apparent throughout the project as well as other intermittent cold spots as evidenced by the multiple infrared images. These temperature differentials will result in drops in compaction. As shown by research done by the state Washington State Department of Transportation, temperature differentials of 25°F or greater result in failing density profiles approximately 90 percent of the time and, conversely where temperature differentials are less than 25°F, approximately 80 percent of the density profiles pass the density criteria (<http://www.wsdot.wa.gov/biz/mats/Pavement/Technotes/TemperatureDifferentialTechNote2001.pdf>). Some states, to ensure passing densities have specified that the mat shall not vary by more than 10° transversely (*Arkansas State Department of Transportation Specification 409.04 (b)*). From this evidence the project shown in this study will most likely result in failing densities and premature failure of the pavement.

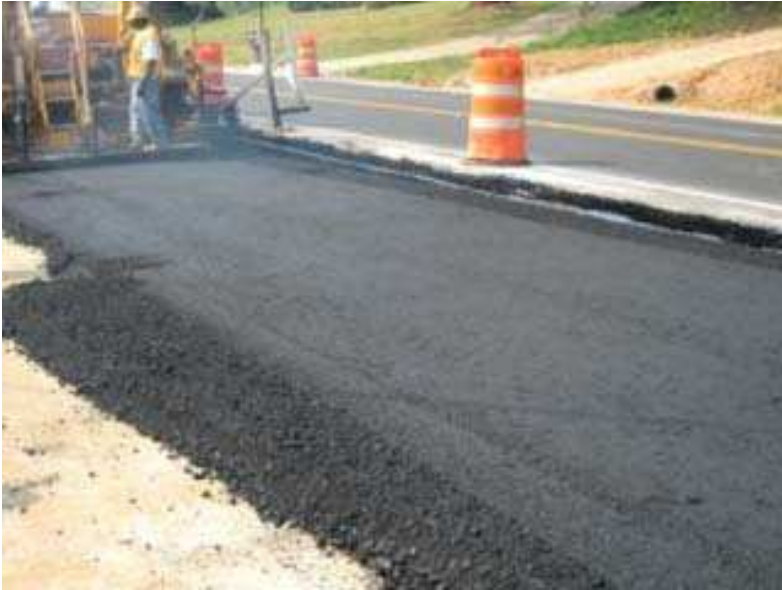
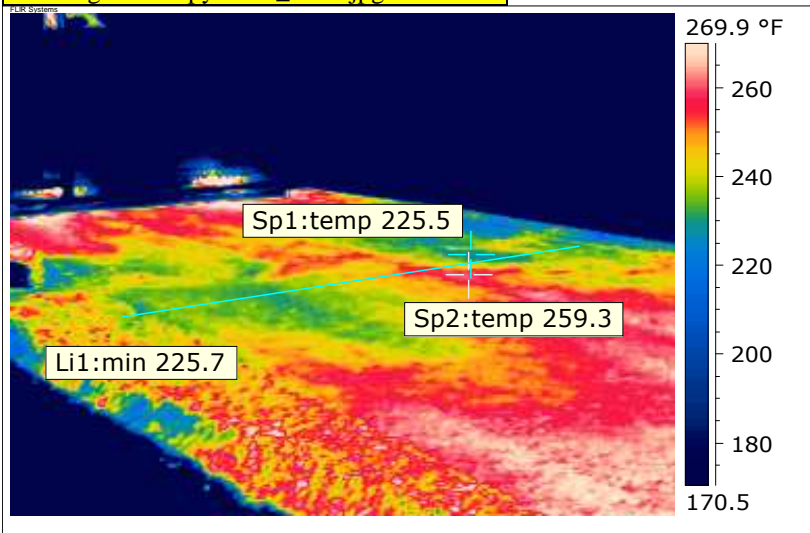
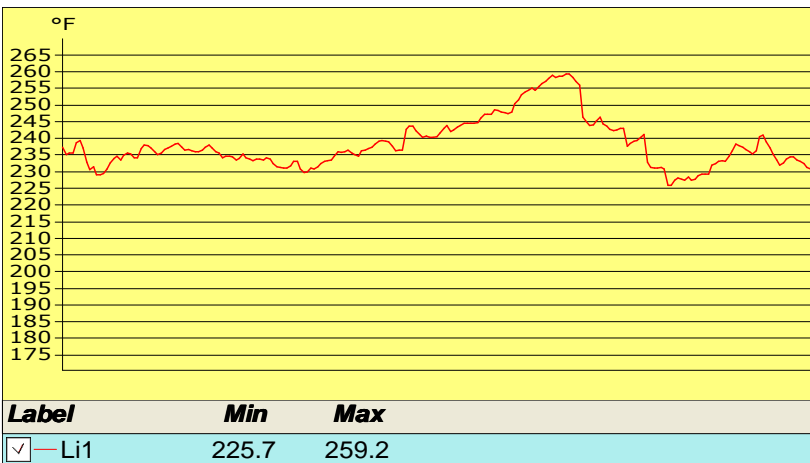
Thermogram: Copy of IR_0075.jpg 5/2/2007

Another end of load segment containing temperature differences greater than 30 degrees across the mat

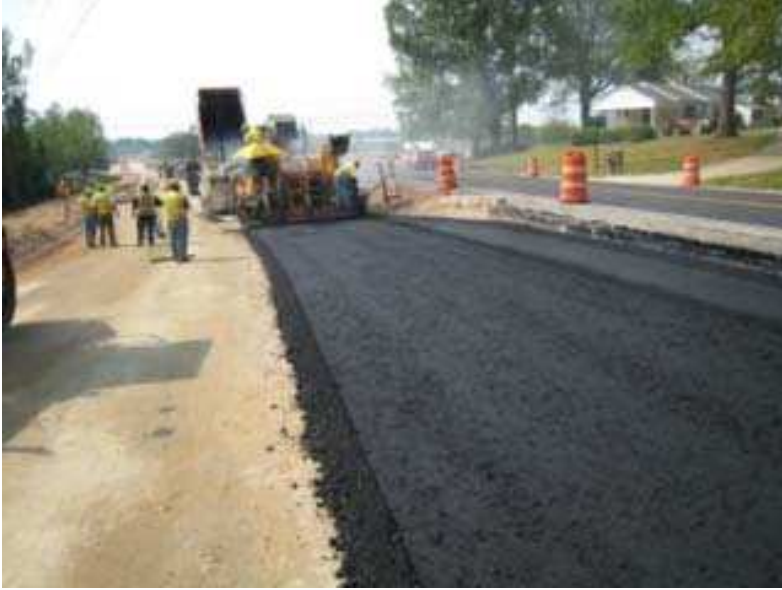
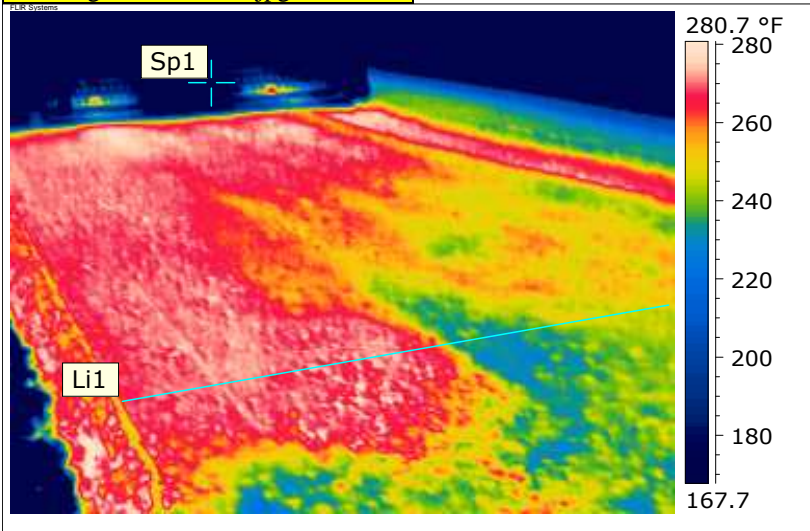
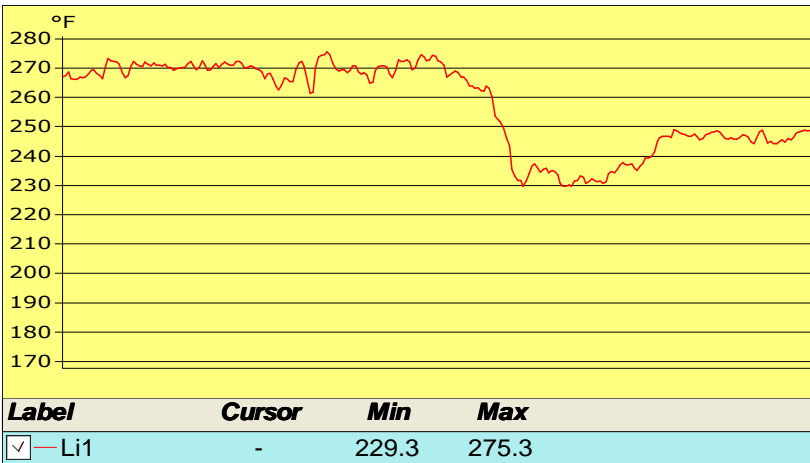
Thermogram: IR_0079.jpg 5/2/2007

Over 45 degree differential.

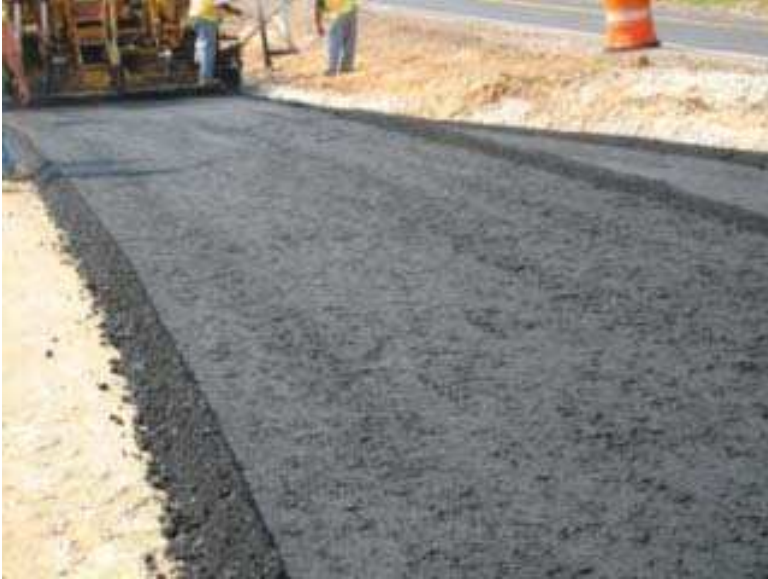
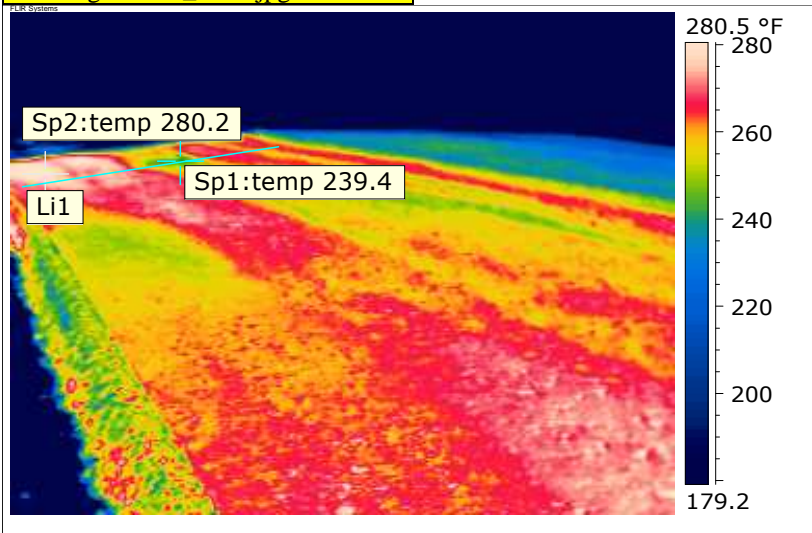
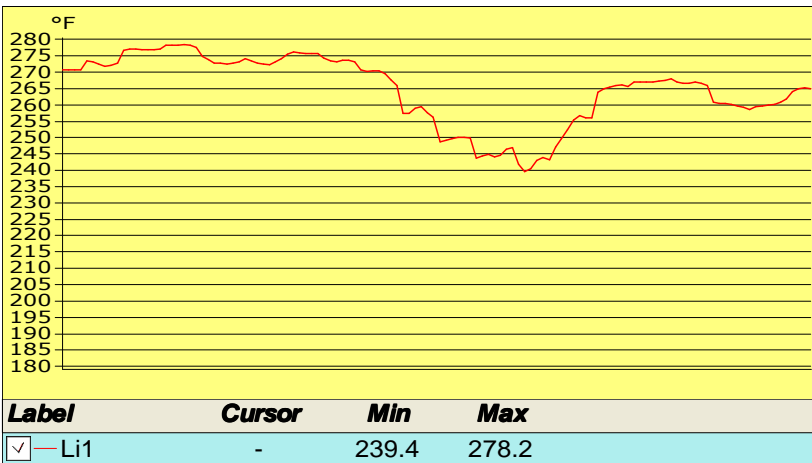
Thermogram: IR_0081.jpg 5/2/2007

Over 40 degree differential.

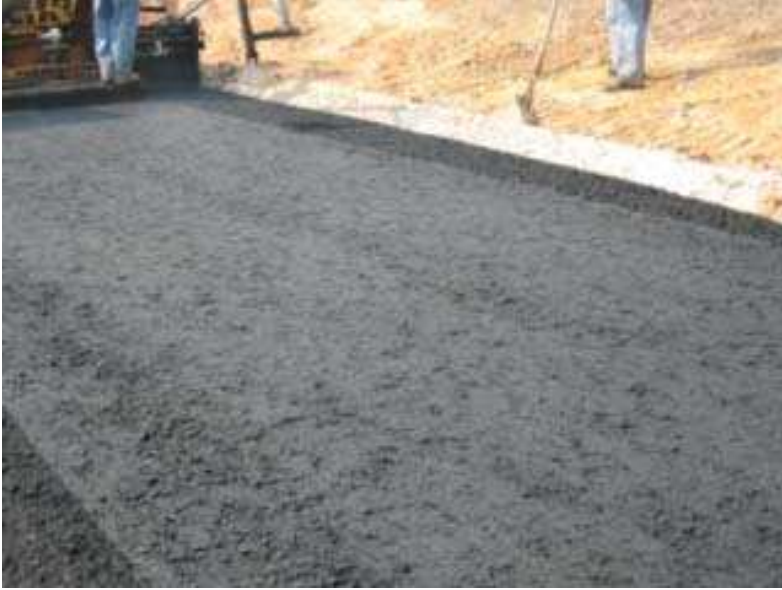
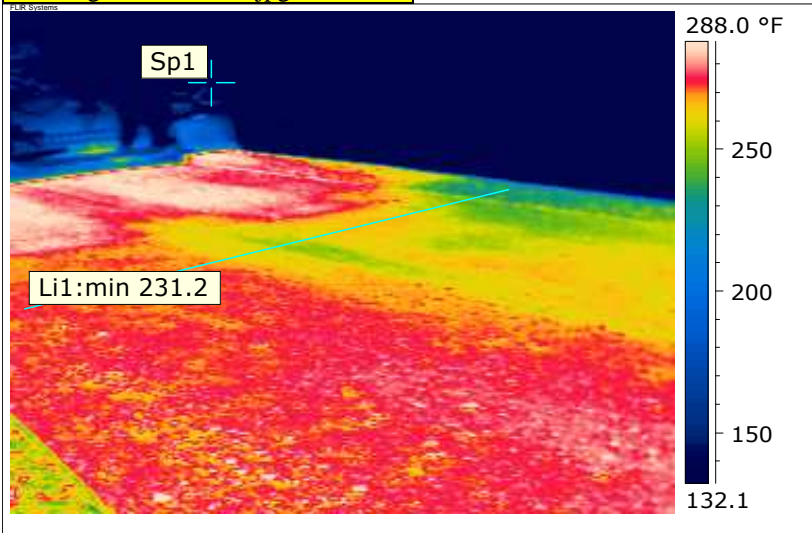
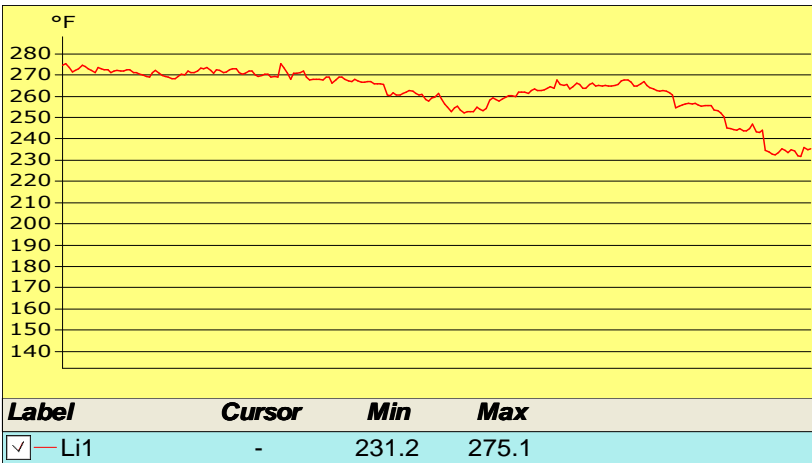
Thermogram: IR_0086.jpg 5/2/2007

Another over 40 degree differential.

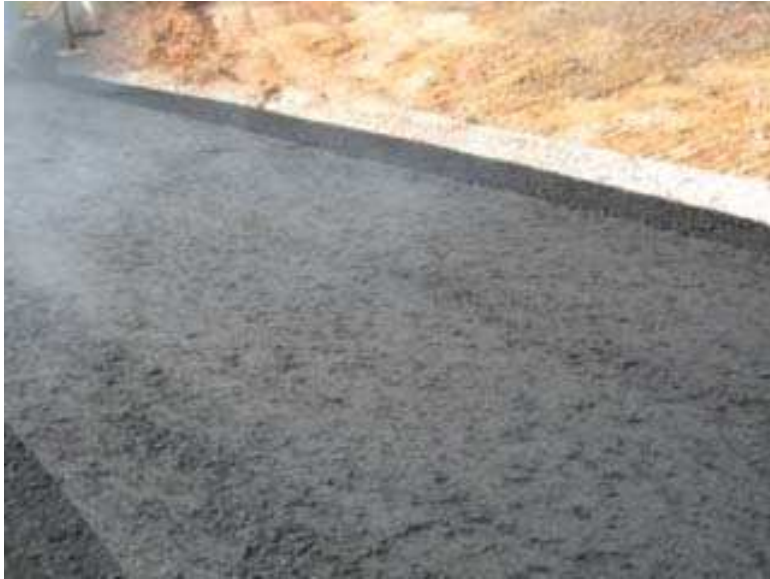
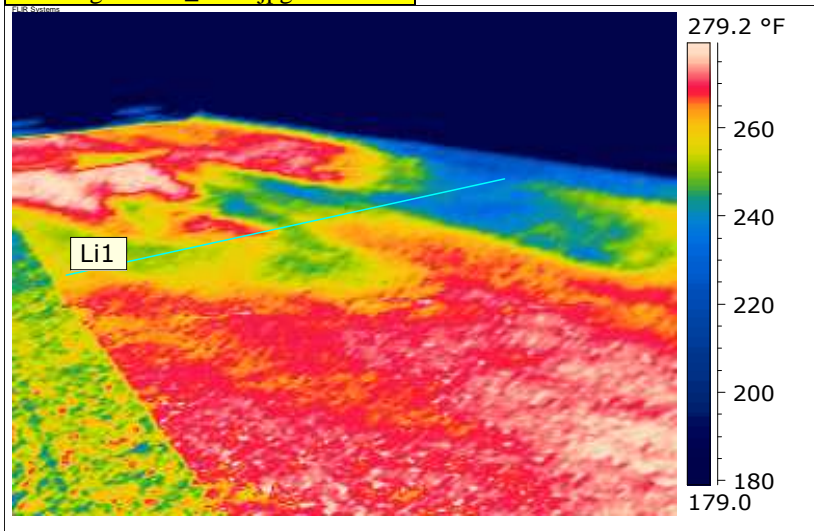
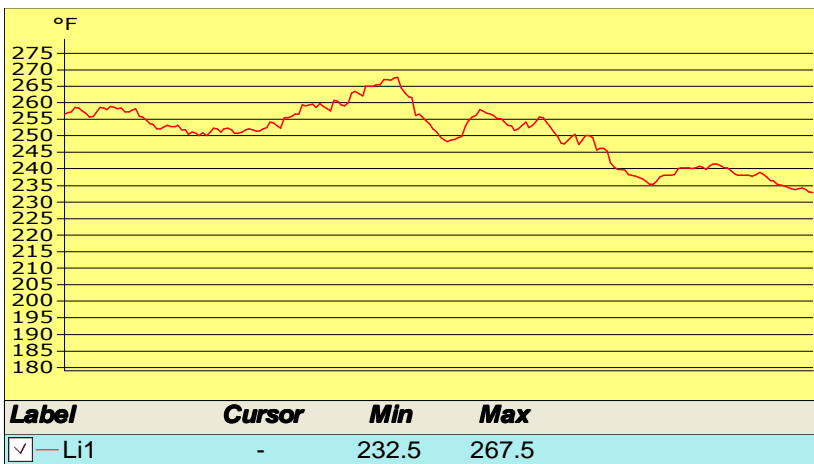
Thermogram: IR_0090.jpg 5/2/2007

Another highly visible end of load cold spot.
